TEAM PROJECT PLANNING WORKSHEET																	
OBJECTIVE			Reduce the final product rejections of Leading Edge Assmblies														
TEAM WORK LOCATION			Stony Brook University														
TEAM NAME			Legion														
DURATION			Fall 2015														
TEAM MEMBERS	TEAM MEMBER 1		Parminder Singh (TEAM LEADER)							TEAM INFORMATION							
	TEAM MEMBER 2		Michael Cusimano														
	TEAM MEMBER 3		Rahul Chhajer														
	TEAM MEMBER 4		Shashank Sharma														
	TEAM MEMBER 5		Kaza Sai Ronit														
MEETING	#	DATE	TIME	ATT	#	DATE	TIME	ATT	#	DATE	TIME	ATT					
	1	8/15/2015	8.00 PM		9	11/22/2015	6.30 PM	TELECONF									
	2	8/23/2015	10.00 AM		10	11/30/2015	TBD	TBD									
	3	8/31/2015	4.00 PM														
	4	9/14/2015	4.00 PM	TELECONF													
	5	9/25/2015	8.00 PM														
	6	10/10/2015	8.00 PM														
	7	10/17/2015	8.00 PM														
	8	11/15/2015	8.00 PM

Problem Statement and Current Situation

XX Corporation is a manufacturer of parts for aircrafts. One of the products they manufacture is the Leading Edge (LE) assembly for the aircraft wings. The company is facing High Rejection rates of LE assemblies at final inspection, which in

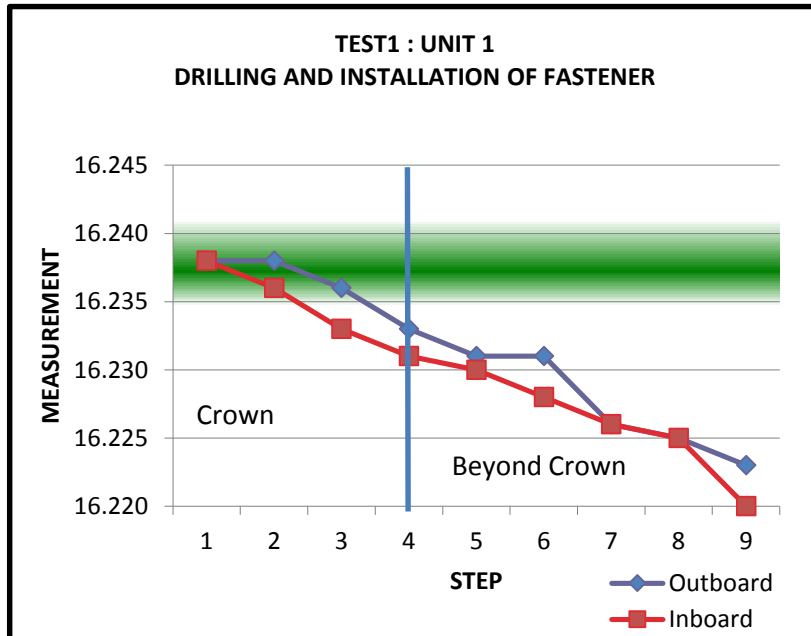
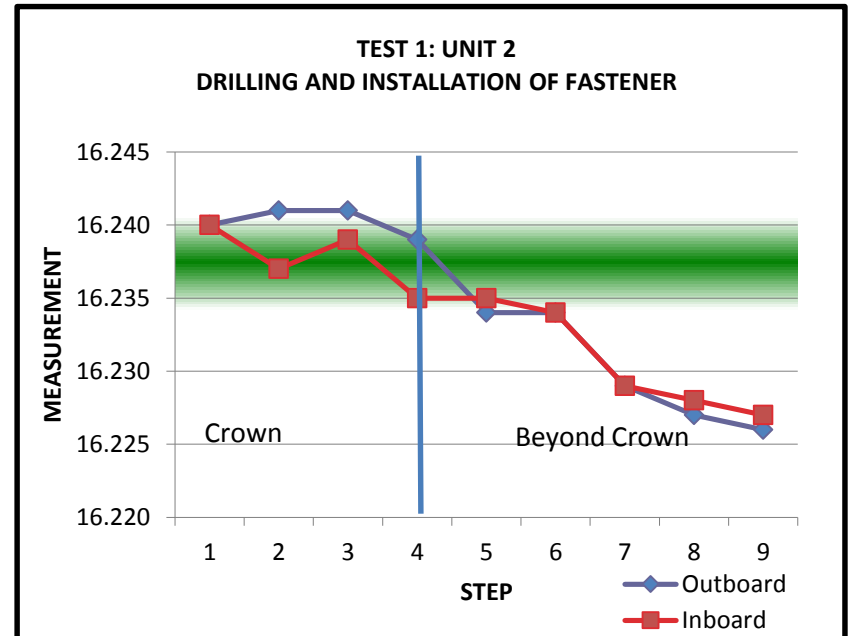
TEST 1

TEST WAS CONDUCTED TO MEASURE THE DEFECTION DURING THE DRILLING AND FASTENER INSTALLATION PROCESS FOR TWO DIFFERENT ASSEMBLIES. THE MEASUREMENTS WERE TAKEN AT EACH PROCESS STEP OF DRILLING AND INSTALLING TWO FASTENERS. THE MEASUREMENTS WERE RECORDED AT EACH STEP.

- 1) THE RIB BEGIN TO DEFLECT AS FASTENERS IN THE CROWN AREA WERE INSTALLED AND TORQUED TO FINAL COLLAR BREAKOFF.
- 2) MEASUREMENTS BETWEEN INBOARD AND OUTBOARD POINTS OF MEASURE ON THE INTERFACE PADS INDICATED THAT THE RIB LEGS TWISTED FROM THEIR FREE STATE CONDITION.
- 3) DEFLECTION OF .015 OUTBOARD AND .020 INBOARD WAS NOTED.

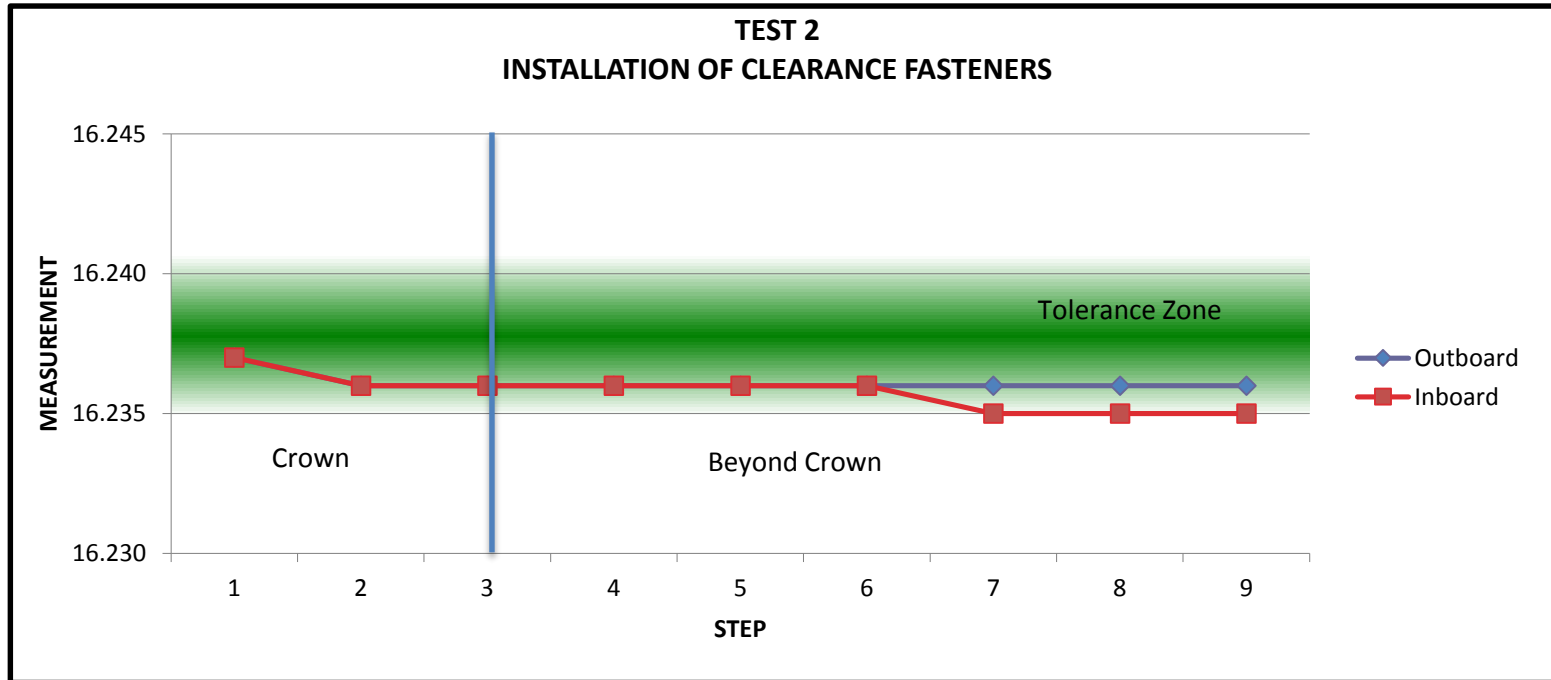
TEST 2 WAS CONDUCTED ON AN ASSEMBLY TO INSTALL CLEARANCE FIT FASTENERS AT THE CROWN AREA TO VALIDATE THE EFFECT OF FASTENER FIT IN THE HOLES.

- 1) THE RIB DIMENSIONS REMAINED STABLE AS FASTENERS OVER THE ENTIRE RIB WERE DRILLED, INSTALLED AND TORQUED TO FINAL COLLAR BREAKOFF.
- 2) MEASUREMENTS BETWEEN INBOARD AND OUTBOARD POINTS OF MEASURE ON THE RIB INTERFACE PADS INDICATED THAT THE RIB LEGS DID NOT TWIST FROM THEIR FREE STATE CONDITION.

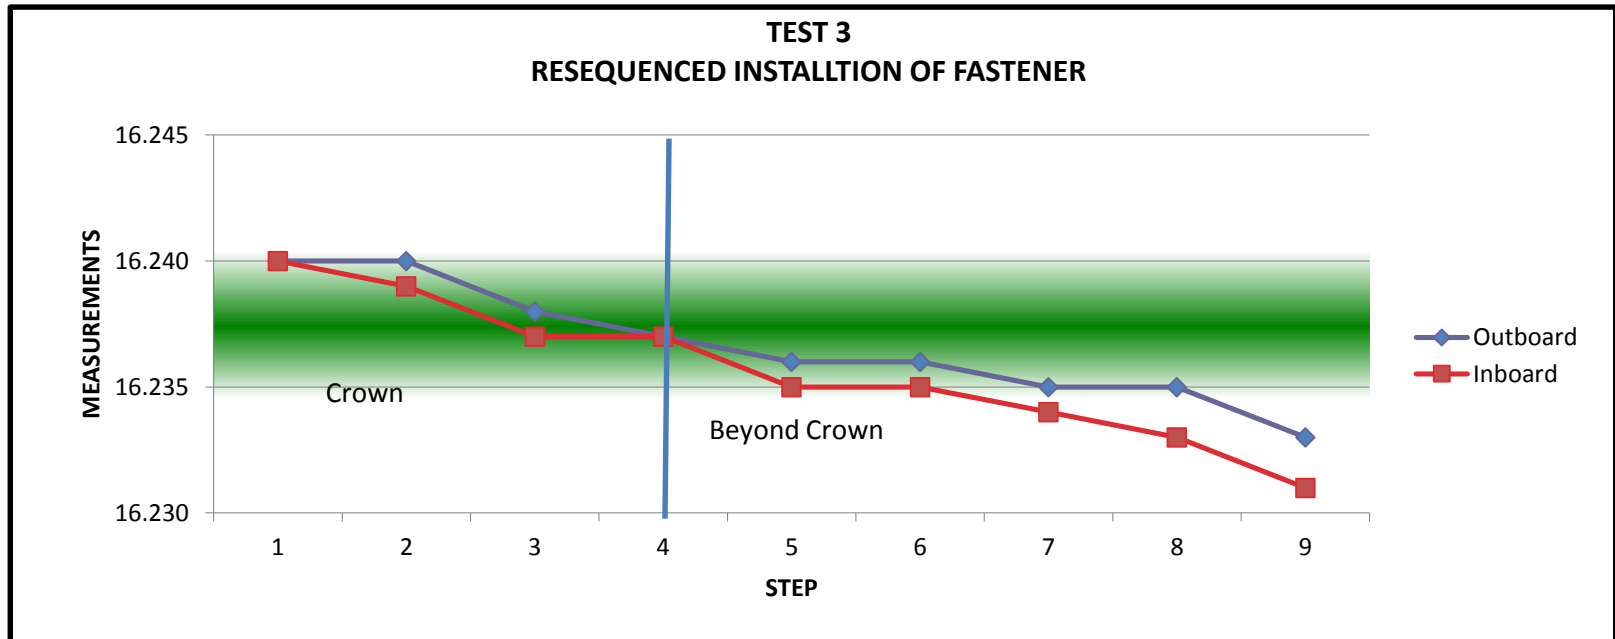
TEST 3 WAS CONDUCTED ON AN ASSEMBLY TO RE-SEQUENCE THE DRILLING AND INSTALLATION OF FASTENERS TO START FROM CROWN AND MOVE TOWARDS THE LEG AND ALTERNATING FROM UPPER TO LOWER LEGS

- 1) THE RIB DIMENSIONS SHOWED DEFLECTION BUT WERE ONLY .003" BEYOND LOW LIMIT.
- 2) MEASUREMENTS BETWEEN INBOARD AND OUTBOARD POINTS OF MEASURE ON THE RIB INTERFACE PADS INDICATED THAT THE RIB LEGS SHOWED TWISTING FROM THEIR FREE STATE CONDITION.

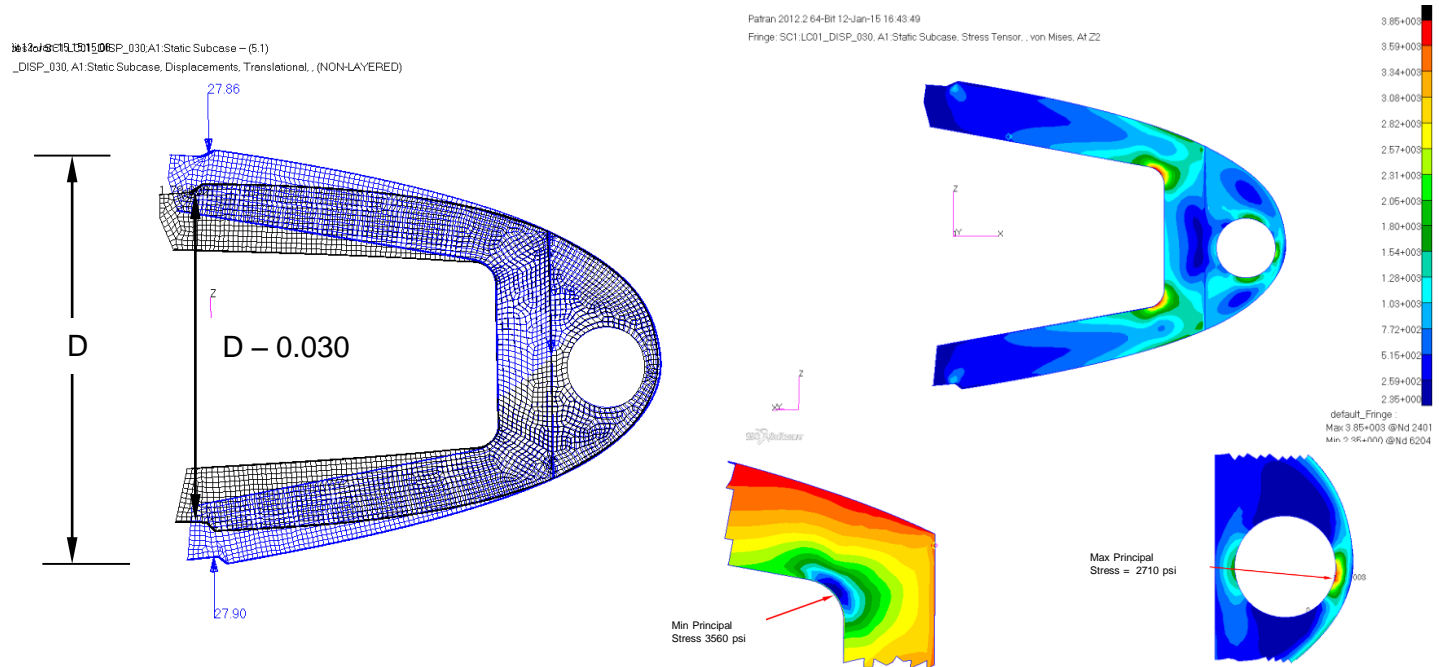
TEST 4

IN TEST 4, FINITE ELEMENT ANALYSIS WAS CONDUCTED TO DEMONSTRATE LOCATION OF STRESS CONCENTRATIONS IN THE PRESENT RIB DESIGN USING A SIMPLE LOADING CONDITION. THE TEST WAS CONDUCTED TO VALIDATE THE LIGHT WEIGHT DESIGN OF THE RIB

LESS THAN 30 LB. IS REQUIRED TO "CLOSE" THE RIB 0.030 IN.

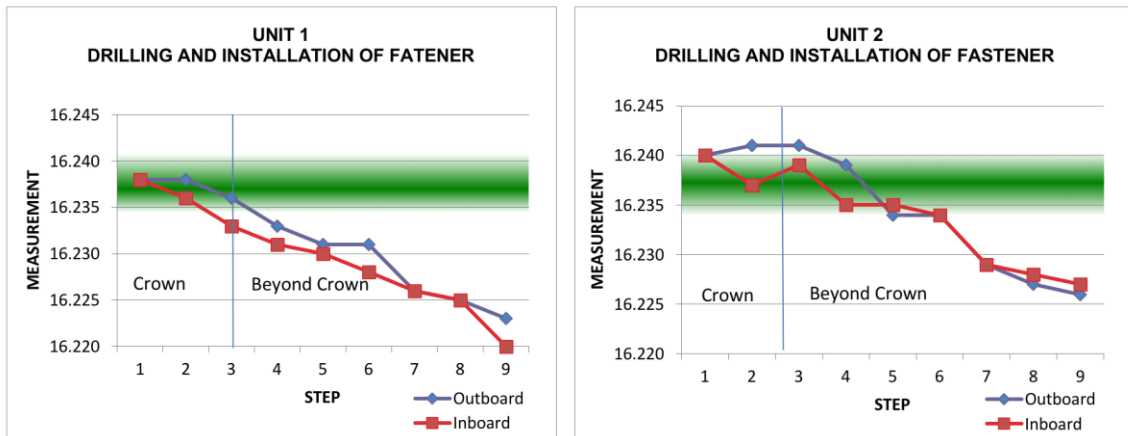
Test 1: Deflection during drilling and installation process

1. Rib begin to deflect as fasteners in crown area were installed & torqued to final collar breakoff
2. Outboard and inboard measurements show that rib legs are twisted from from free state condition
3. Inboard deflection is 0.02 inch and outboard deflection 0.015 inch

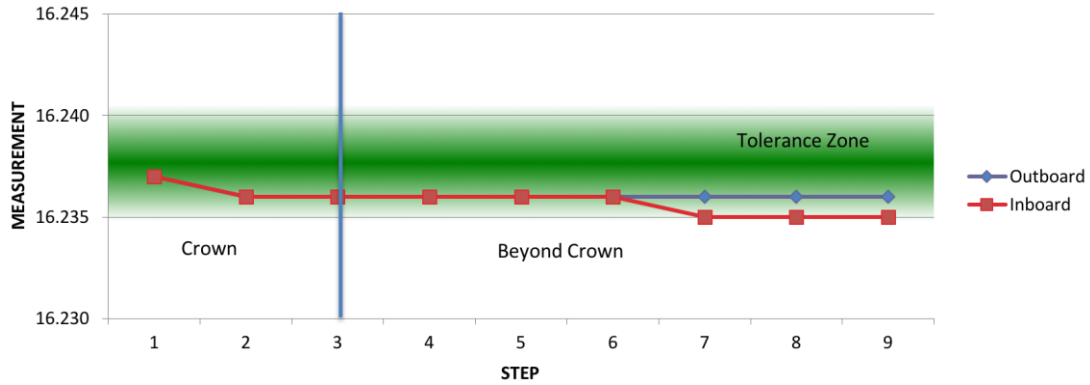
Test 2: Clearance fit on fasteners at crown area over interference fit

1. Throughout assembly process the rib dimensions remained constant.
2. Rib legs did not twist as we observed find during test 1

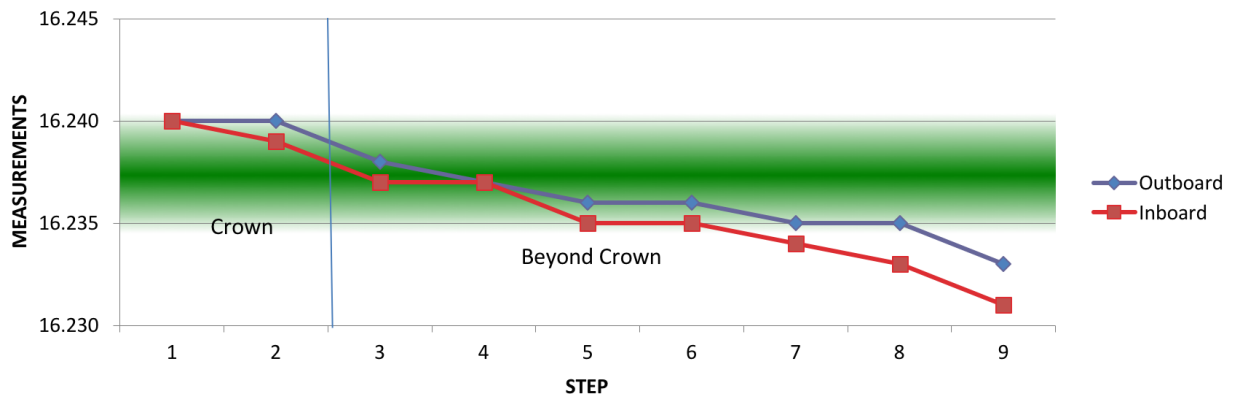
Test 3: Re-sequence drilling and installing from crown toward leg

1. Rib was deformed by about 0.003 inch below lower limit
2. Rib legs are twisted from their free state position

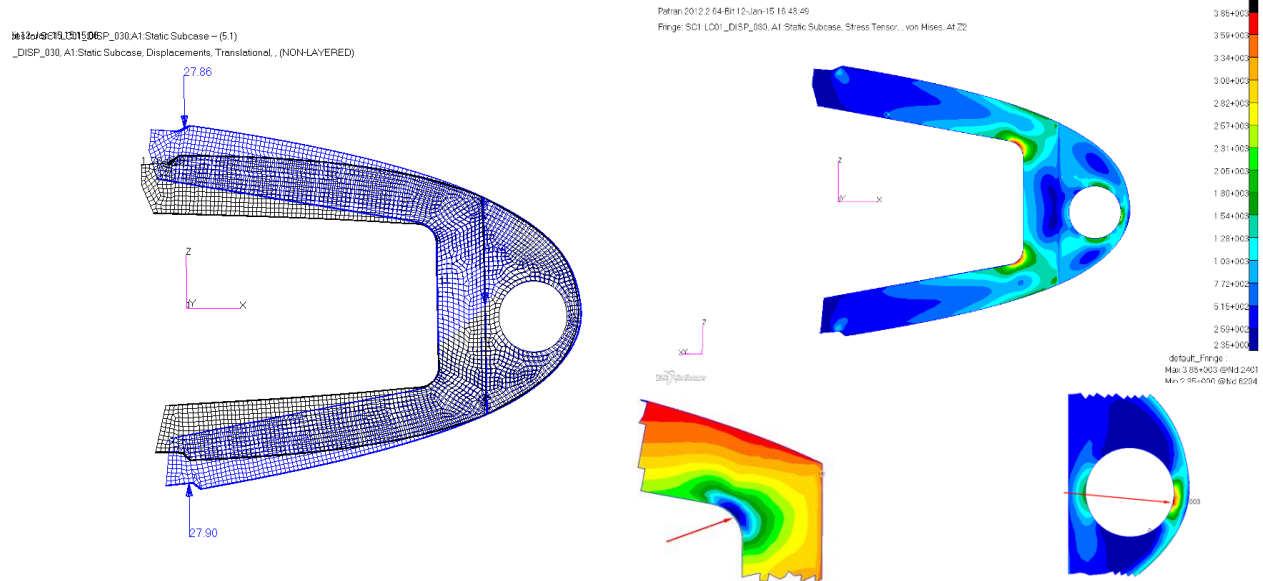
Test 4: FEA analysis

1. Design of rib is comparatively weak. Maximum force it can take without any permanent deformation is about 30 lb.
2. About 45 lb. force need to be applied during assembling causing rib to close before its desired limit.

1. Re-sequence the drilling and installation sequence
2. Change transition fit to clearance fit (Test 3 clearly shows much improvement)
3. Redesign ribs with increased strength (FEA analysis shows why this is needed). Since these parts are proprietary design from a customer, a request was made to customer to improve on design.
