TEAM PROJECT PLANNING WORKSHEET																	
OBJECTIVE			Reduce the final product rejections of Leading Edge Assmblies														
TEAM WORK LOCATION			Stony Brook University														
TEAM NAME			Legion														
DURATION			Fall 2015														
TEAM MEMBERS	TEAM MEMBER 1		Parminder Singh (TEAM LEADER)							TEAM INFORMATION							
	TEAM MEMBER 2		Michael Cusimano														
	TEAM MEMBER 3		Rahul Chhajer														
	TEAM MEMBER 4		Shashank Sharma														
	TEAM MEMBER 5		Kaza Sai Ronit														
MEETING	#	DATE	TIME	ATT	#	DATE	TIME	ATT	#	DATE	TIME	ATT					
	1	8/15/2015	8.00 PM		9	11/22/2015	6.30 PM	TELECONF									
	2	8/23/2015	10.00 AM		10	11/30/2015	TBD	TBD									
	3	8/31/2015	4.00 PM														
	4	9/14/2015	4.00 PM	TELECONF													
	5	9/25/2015	8.00 PM														
	6	10/10/2015	8.00 PM														
	7	10/17/2015	8.00 PM														
	8	11/15/2015	8.00 PM

Problem Statement and Current Situation

XX Corporation is a manufacturer of parts for aircrafts. One of the products they manufacture is the Leading Edge (LE) assembly for the aircraft wings. The company is facing High Rejection rates of LE assemblies at final inspection, which in

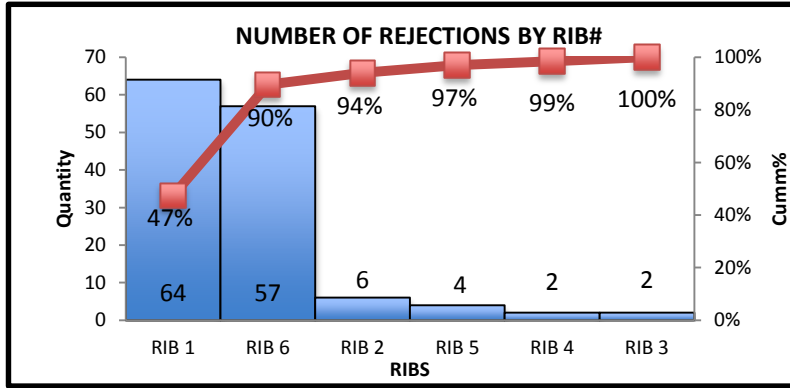
90% OF THE REJECTIONS IN LE-02 ARE CAUSED DUE TO RIB HEIGHT ISSUES IN RIB#1 AND RIB#6

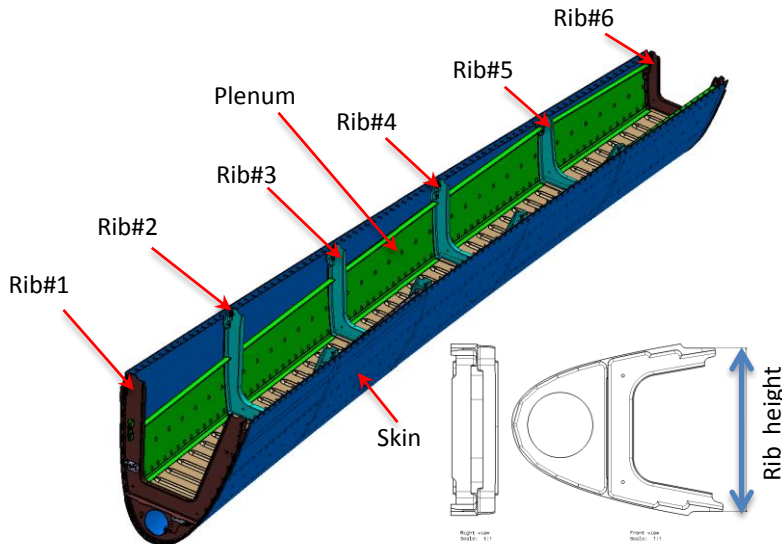
THE RIB HEIGHT DATA OF RIB#1 AND RIB#6 FROM REJECTED UNIT <AS ASSEMBLED CONDITION> WAS ANALYZED

THE RIB HEIGHT DATA OF DETAILED RIB#1 AND RIB#6 WAS ALSO ANALYZED AND FOUND TO BE IN TOLERANCE

THIS ANALYSIS SHOWED THAT RIBS ARE FOLLOWING OOT AFTER ASSEMBLY PROCESS

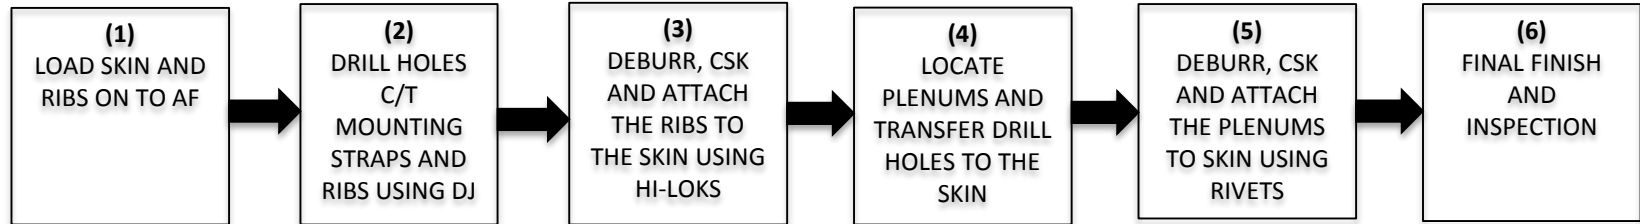
RIB HEIGHT MEASUREMENTS ON RIB #1 AND RIB# 6 WERE TAKEN AT EACH STEP OF THE BUILD PROCESS FOR TWO CONSECUTIVE UNITS

MAJOR DEVIATION IN THE RIB HEIGHT IS OBSERVED AFTER THE INSTALLATION OF HILOKS WHICH ARE USED TO SECURE THE RIB TO THE SKIN.

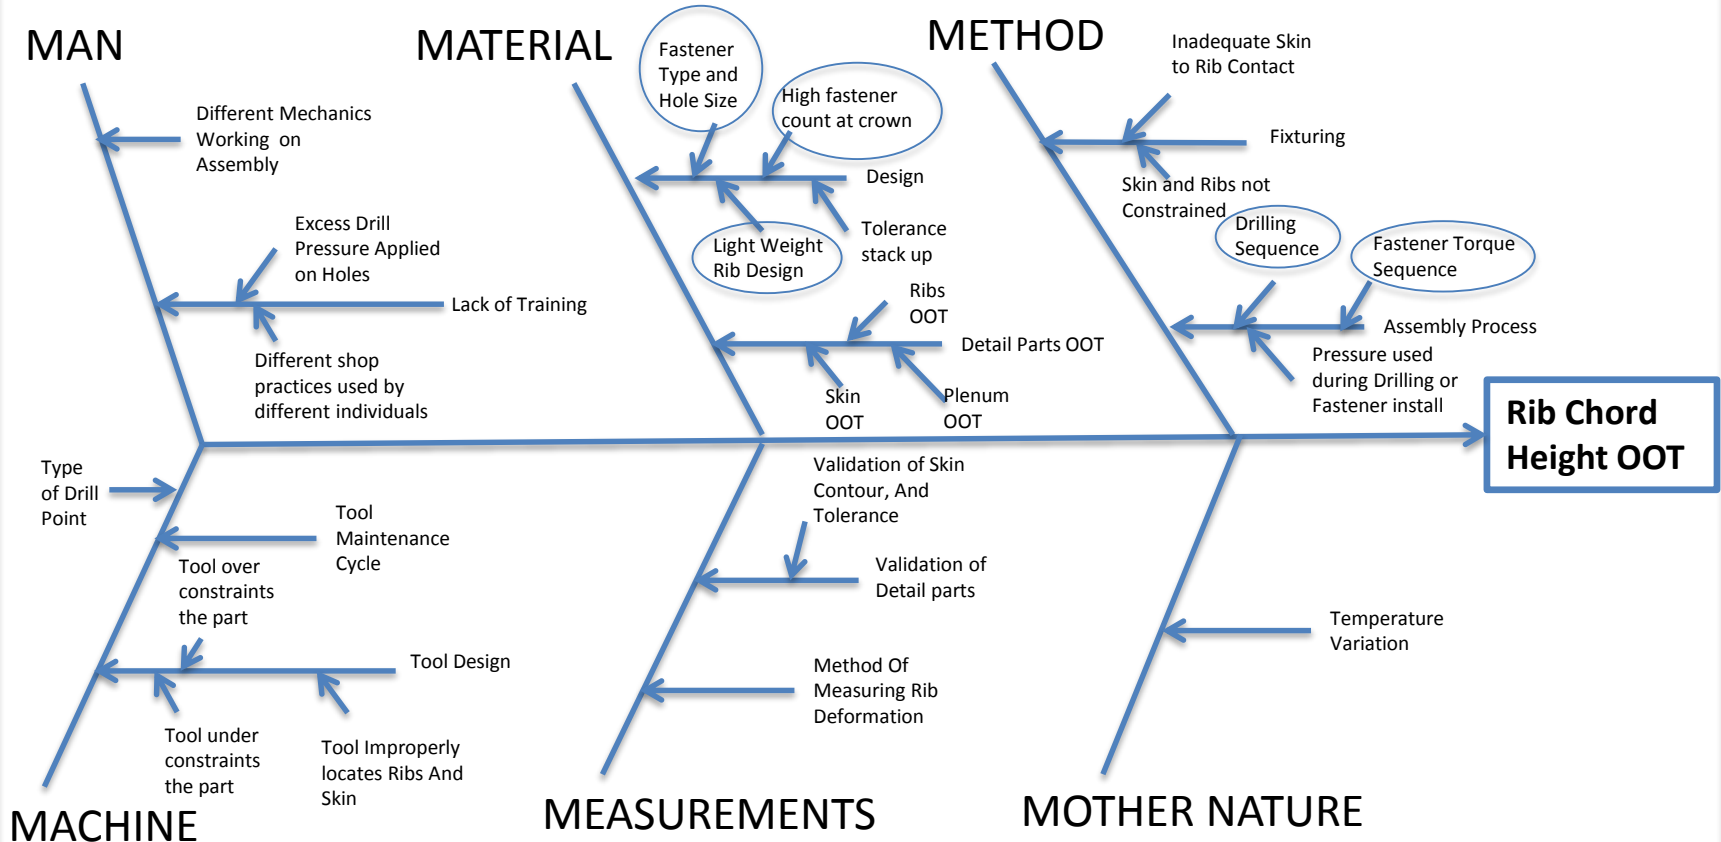
THE TEAM REACHED FOLLOWING CONSENSUS ON THE PROBABLE ROOT CAUSES

1. DRILLING SEQUENCE AND FASTENER INSTALLATION PROCESS DURING THE ASSEMBLY PROCESS
2. THE DESIGN OF THE ASSEMBLY
 - A. NUMBER OF FASTENERS IN THE CROWN AREA AND THE FIT OF FASTENERS
 - B. THE LIGHT WEIGHT DESIGN OF THE RIB

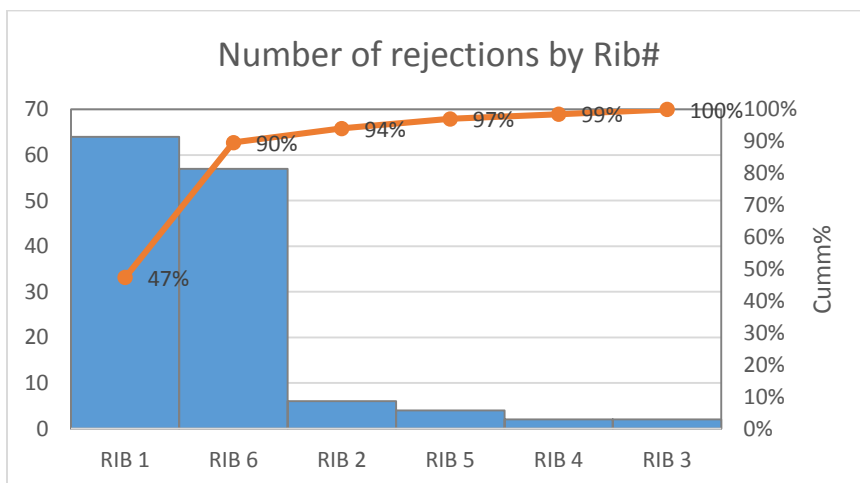
Height of rib number 1 and rib number 6 caused about 90% of total failures. The team decided to work on rib height issue in Rib #1 and #6 of LE02 assembly in accordance with Juran's ideology.

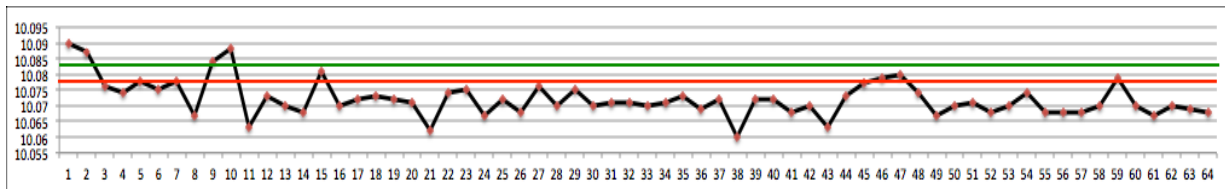
Height variation of Rib # 1

Final inspection data of the assembly was analyzed. Ribs were falling out of tolerances after assembly.

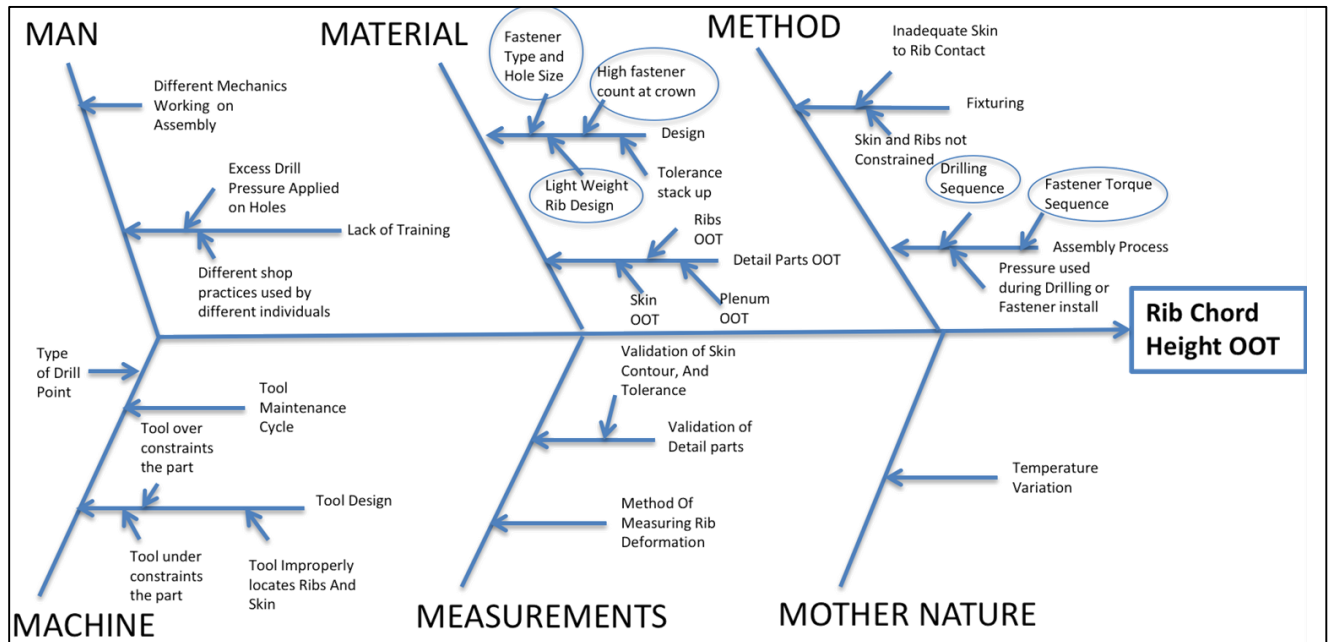
Cause and Effect Diagram

Following key root causes were identified based on discussion with cross functional experts and brainstorming within team

1. Improper drilling sequence and fastener installation could cause deformation of parts
2. Design parameters such as
 - a. High number of fasteners in crown area could cause rib structures to deform due to tight pitch (13 hiloks fasteners in 5 inch spaces).
 - b. Type of fit of fasteners and dimensions of fastener holes- The accumulated interference from the crown to leg could cause the rib to bend.
 - c. Light weight design of rib- the sub pressure defects with minimal
